# Manhole Inspection Summary

Manhole # S39W1\_010MH

Insp Date: **11/16/07 1:18 PM**

**Location** Address: **501 Maude Ave**

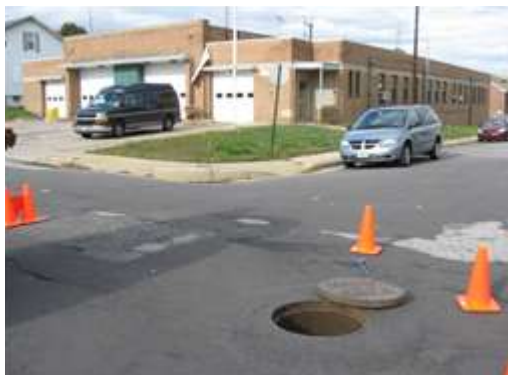
Location View

Intersection 5th & Maude Ave

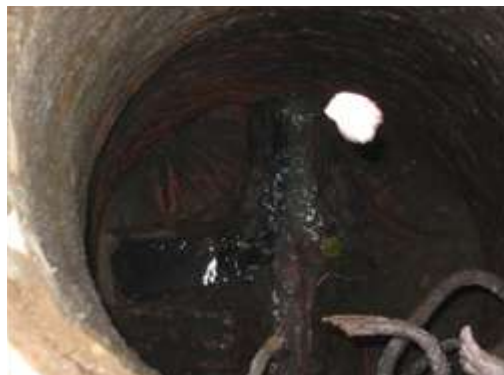
Top View

Abandoned pipe @ 4o'clock

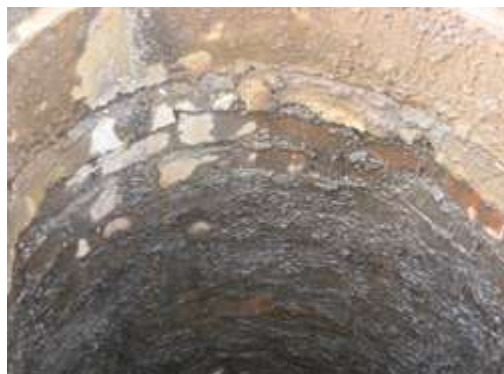
Defect 1

Condition: ☐ Sound ☐ Cracked ☐ Root Intrusion ☒ Loose Brick ☒ Deteriorated

Infiltration: ☐ None ☐ Joint ☒ Cracks ☒ Mortar ☐ Roots ☐ Wall

Chimney cracks/Infiltration

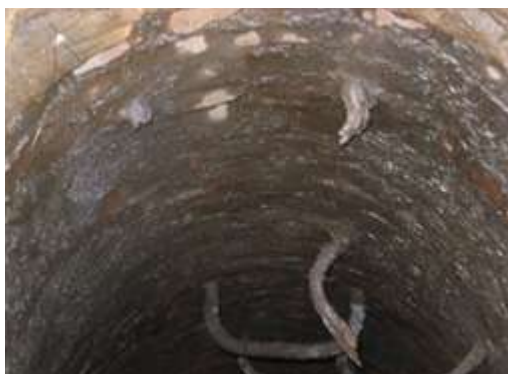
Count: **5** Missing: **2** ☒ Corroded

Corroded Steps

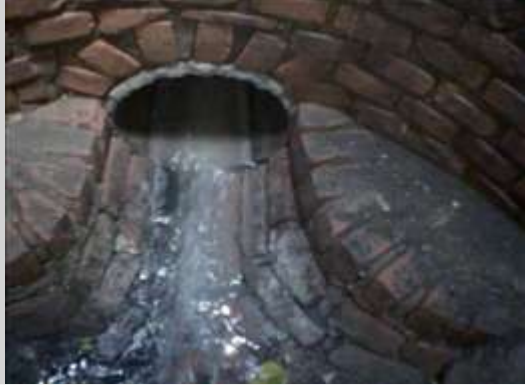
12 O'Clock Outflow

12 in. Circular Gravity Sewer  
Pipe Out @ 12 O'Clock

Pipe Height: **15.6** (in.) Rod and Bar (Angled)  
Pipe Material: **Clay** ☐ Pipe Lined  
Invert Depth: **12.89** (ft.) Flow Characteristics: **Fast**  
Deposits: ☒ None ☐ Mud ☐ Sludge ☐ Debris ☐ Grease  
Silt Depth: (in.) Deposits Extent:  
Infiltration: **None** Pipe Seal Cond: **Sound**

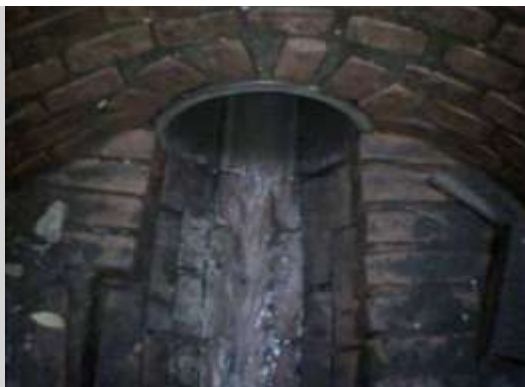
6 O'Clock Inflow

12 in. Circular Gravity Sewer  
Pipe In @ 6 O'Clock

Pipe Height: **14.4** (in.) Rod and Bar (Angled)  
Pipe Material: **Clay** ☐ Pipe Lined  
Invert Depth: **12.56** (ft.) Flow Characteristics: **Fast**  
Deposits: ☒ None ☐ Mud ☐ Sludge ☐ Debris ☐ Grease  
Silt Depth: (in.) Deposits Extent:  
Infiltration: **None** Pipe Seal Cond: **Sound**

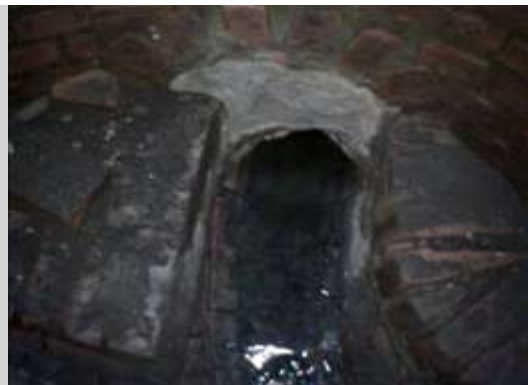
8 O'Clock Inflow

8 in. Circular Gravity Sewer

Pipe In @ 8 O'Clock

Infiltration: **None** Pipe Seal Cond: **Cracked**
